Reducing Bond Failures Caused by Moisture Vapor Transmission

By: Robert R. Cain

Coating concrete with impermeable coatings or other floor surfacings that do not “breathe” requires special considerations to prevent failure.

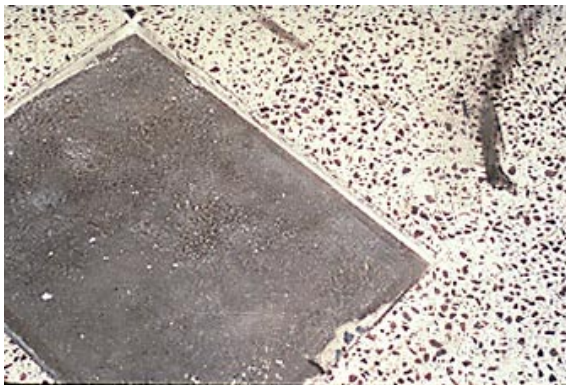
Photo 1—Epoxy Terrazzo Moisture Vapor Failure

Photos #1 and #2 show the effect of moisture vapor transmission on impermeable and permeable floor systems. Photo #1 is an epoxy terrazzo surface (impermeable) which has completely lost bond and has water lying in the exposed area. Photo #2 is also a terrazzo surface, but in this case it is a permeable, cement-based system. Moisture migration is plainly visible around the panels of terrazzo defined by zinc divider strips. Moisture is

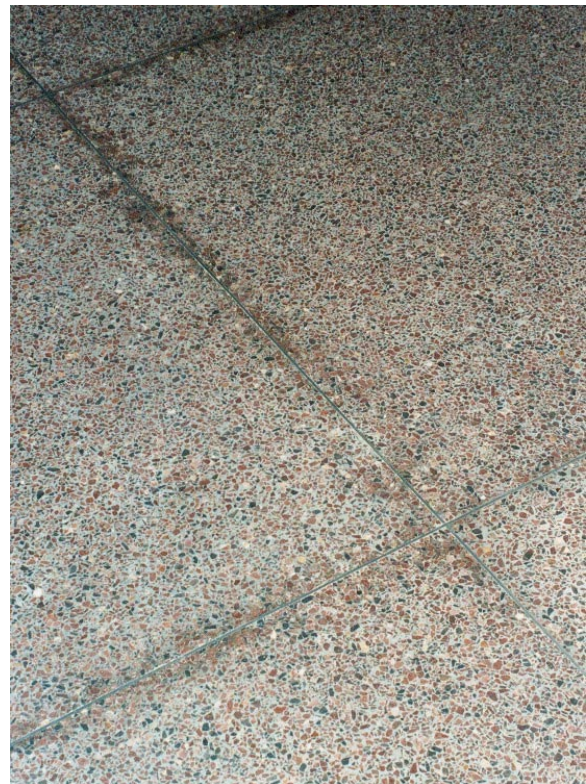
Photo 2—Moisture Vapor Transmission through Polyacrylate Terrazzo Joints

transmitting along the path of least resistance, but is not affecting the bond or adhesion of the terrazzo to the concrete substrate.
